**Homeowner  
Address  
Date**

**Prioritized Recommendations:**

<p><b>Overview:</b> Excessive paint chipping is believed to be caused by unorthodox framing techniques where the interior wall cavities intersect with the exterior wall cavities. This, plus non-back-primed siding and slumping cavity insulation is allowing for excessive moisture build-up in the cavities and dew point formation on the exterior siding causing peeling paint.</p>	<p><b>Outline of Report Contents:</b></p> <ol style="list-style-type: none"> <li>1. Shell             <ol style="list-style-type: none"> <li>a. Air leakage, Sidewalls, &amp; Windows</li> <li>b. Attic</li> <li>c. Basement &amp; Foundation</li> <li>d. Fresh Air &amp; Moisture Management</li> </ol> </li> <li>2. Appliance Efficiency &amp; Performance             <ol style="list-style-type: none"> <li>a. Heating System</li> <li>b. Cooling System</li> <li>c. Electrical Savings Opportunities</li> <li>d. Carbon Monoxide Safety</li> <li>e. Indoor Environmental Hazards</li> </ol> </li> <li>3. Rewards and Follow up</li> </ol>

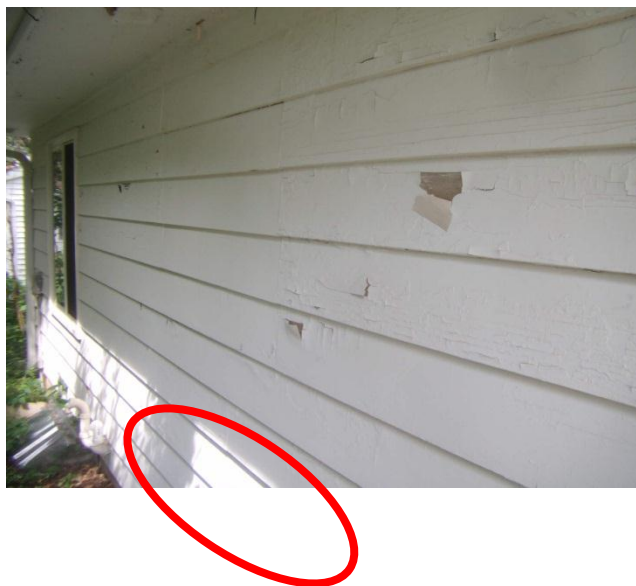
- i. Insulate the exterior sidewalls: Exterior Application: insulate the exterior sidewalls by temporary removal of the existing siding (wood lap) material. Dense pack all cavities by tube method.
  1. At the main floor bathroom note the tub cavity. Consider either filling the tub void with insulation or fully removing the siding to access the tub cavity and installing a solid barrier between the tub cavity and the exterior sidewall cavity. See photo below.

Approximate location of tub cavity.

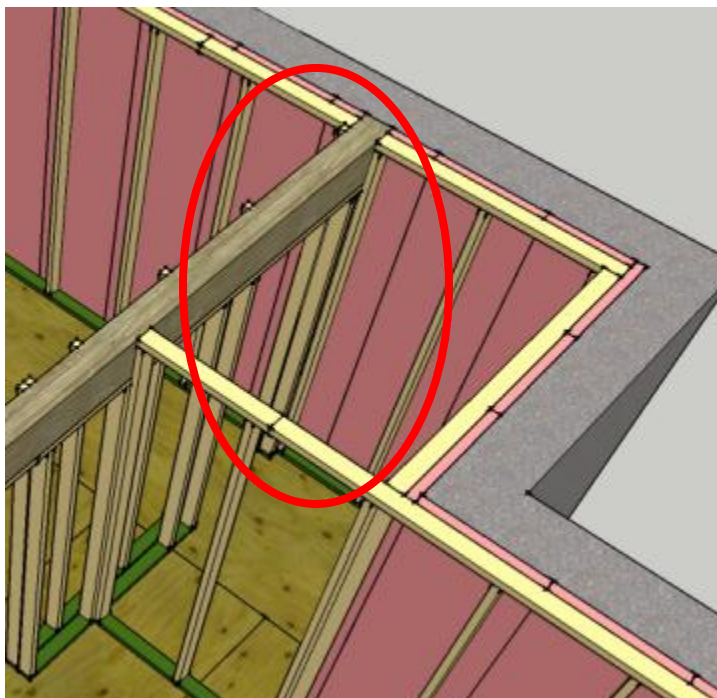
- ii. Interior sidewall interface with exterior wall cavities:
  - 1. Given the likely absent back-primed siding, it may be very reasonable to remove the siding to install back priming. Note that the labor to remove, paint, and reinstall existing siding may make installation with new, back-primed siding reasonable. Whenever the siding has been removed, also take the next step to remove sheathing from those areas where the interior walls intersect the exterior walls to expose the union. Air seal any open cavities with 2" applied spray foam or rigid sheet goods. See diagram below.
  - 2. Note that if this theory is correct then it should apply to all areas where interior walls intersect exterior walls which is mostly true. However the inverse should be true as well but the garage sidewall is also chipping without intersecting interior walls or access to house moisture.

This is an example of a framing detail (generalized – not from your house) showing what I believe to be an absent back-plate).

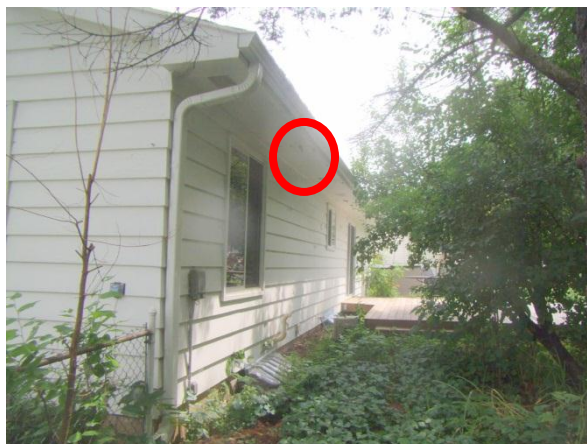
- i. The old bath fan termination was left in the soffit overhang and is neither operable nor required. Consider complete removal if the soffit is rebuilt or resurfaced.
